TYRONE RESERVOIR 1

National Dam Inspection Program.
Tyrone Reservoir 1 (NDI ID 536),
Susquehanna River Basin, Sink Run, Blair
County, Pennsylvania.

PHASE I INSPECTION REPORT.

TYRONE RESERVOIR NO. 1
NDI I.D. NO. 536
JULY 11, 1978

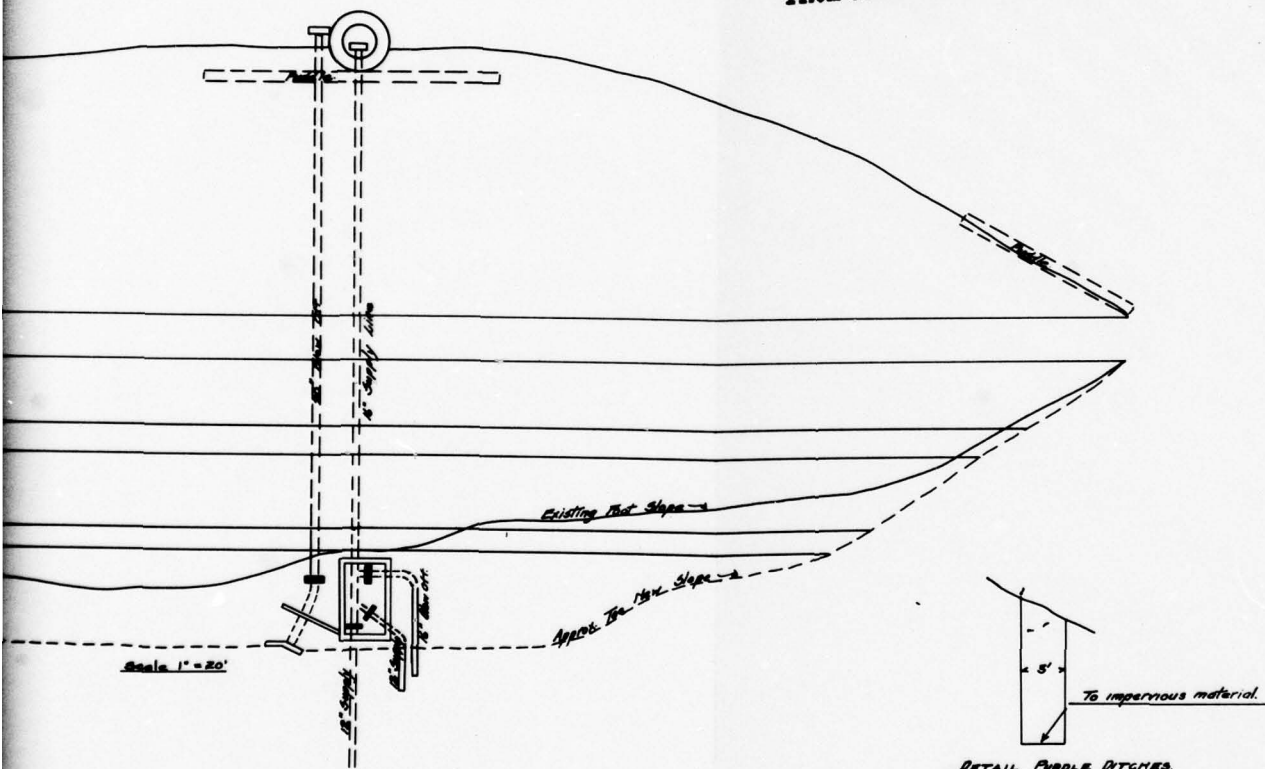
PLATE 3

- c. In 1919, additional porous fill was placed on the downstream face of the dam starting at a level about 14 feet below the crest of the dam to reduce the slope from 1.5:1 to 2:1 (Plate 3). The purpose of this fill was reported to be to strengthen the embankment in view of the seepage problems encountered after the enlargement of the dam in 1910. The source of seepage through the embankment was attributed to the water entering into the embankment at the interface of the old dam and the fill placed in 1910.

The 1919 repairs included reconstruction of a portion of the puddle clay cutoff trench at the toe of the upstream slope.
